# The REMR Bulletin

News from the Repair, Evaluation, Maintenance,  
and Rehabilitation Research Program

VOL 7, NO. 2

## Underwater – Quick Set and Cement Grouting, An Innovative Method to Rehabilitate Milwaukee Harbor Breakwater

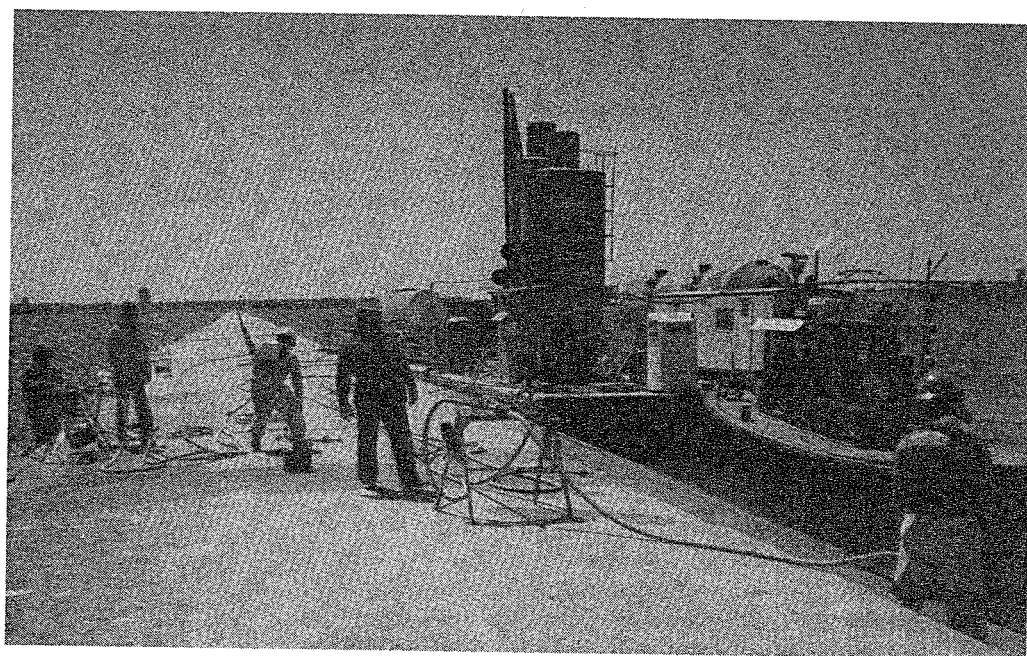
Grouting operations at Milwaukee Harbor, Wisconsin, breakwater rehabilitation project

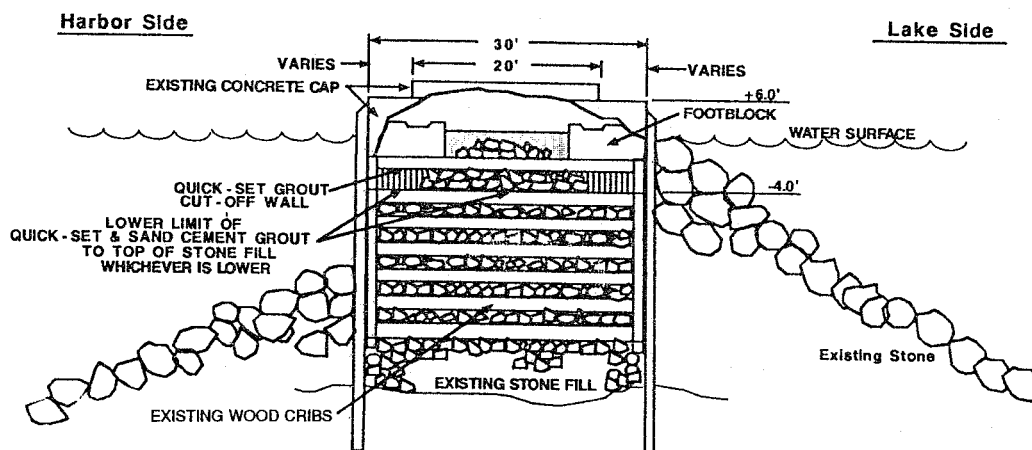
Figure 1. Schematic of a typical section of breakwater at Milwaukee Harbor, Wisconsin

crete superstructures (caps and foot blocks) were added between 1903 and 1909. The caps are 5-ft-thick, mass concrete with minimal reinforcing steel. They rest on 3-ft-thick, precast foot blocks. Steel sheet piling and concrete repairs were performed in the 1950's and early 1960's (Fig. 1).

Partial loss of the stone fill reduced support for the concrete caps, resulting in settlement of the caps, cracking and outward bending of the steel sheet piling, and

breaking of the tie rods. More of the smaller, interior stone fill, exposed to waves, washed out. To protect the failing steel sheet piling, armor stone was placed along the face of the structure. The structure deteriorated to the point that when waves impacted on the lake side of the breakwater, they would transmit through the structure. It became apparent that the loss of stone fill was progressing at an accelerating rate. A decrease in structure weight resulting from loss of stone fill weight, which resists sliding and overturning, caused the structure to be unstable. Left unchecked, the structure was bound to fail, exposing the harbor features.

The repair method finally chosen was to grout the interior of the structure. This method would:

- Resupport the concrete cap and prevent future settlement.
- Prohibit additional loss of the stone fill.
- Add weight to the structure to once again make it stable and resistant to overturning and sliding.

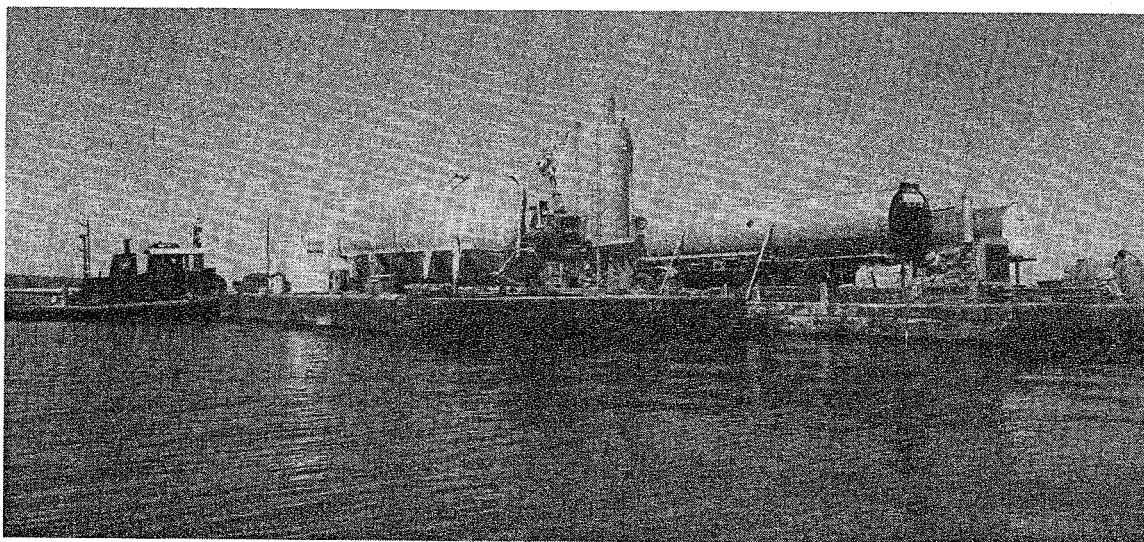
**Figure 2. Tugboat and quick-set grout batch plant mounted on barges shown on location at Milwaukee Harbor.**

The contractor purchased and mobilized a fully automated, computer operated batch plant. The plant was comprised of a sand bin, cement silo, fly-ash silo, and a heavy duty continuous mixer. The plant was fixed to a barge that was towed daily to the breakwater (Fig. 2).

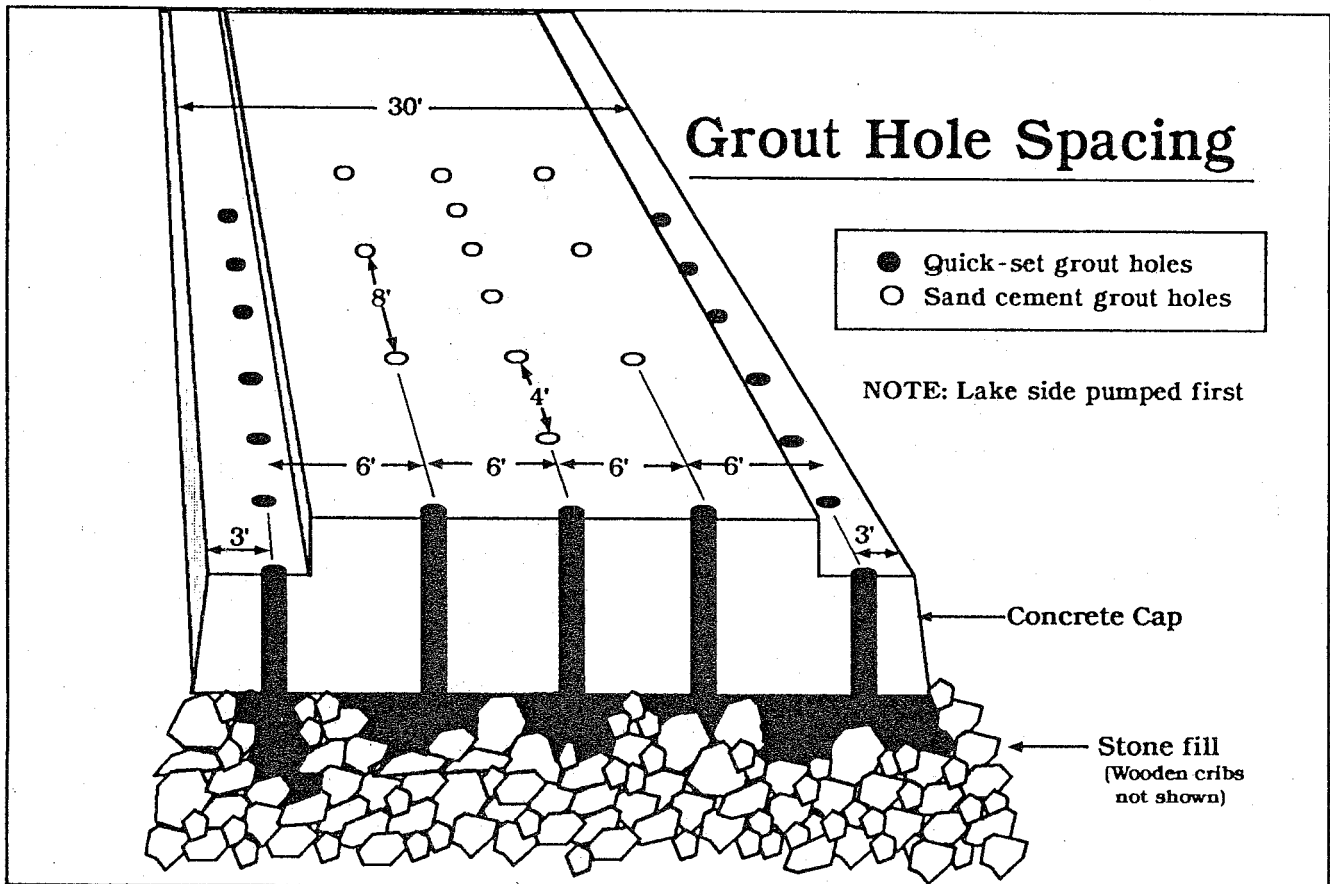
Figure 3. Schematic showing spacing of grout holes for Milwaukee Harbor breakwater rehabilitation.

First, the quick-set holes were drilled on a 4-ft spacing, three feet in from the face of the structure. These holes were grouted in a "leapfrog" manner, with primary grouting on an 8-ft spacing. Secondary grouting was done on the intermediate holes (Fig. 3).

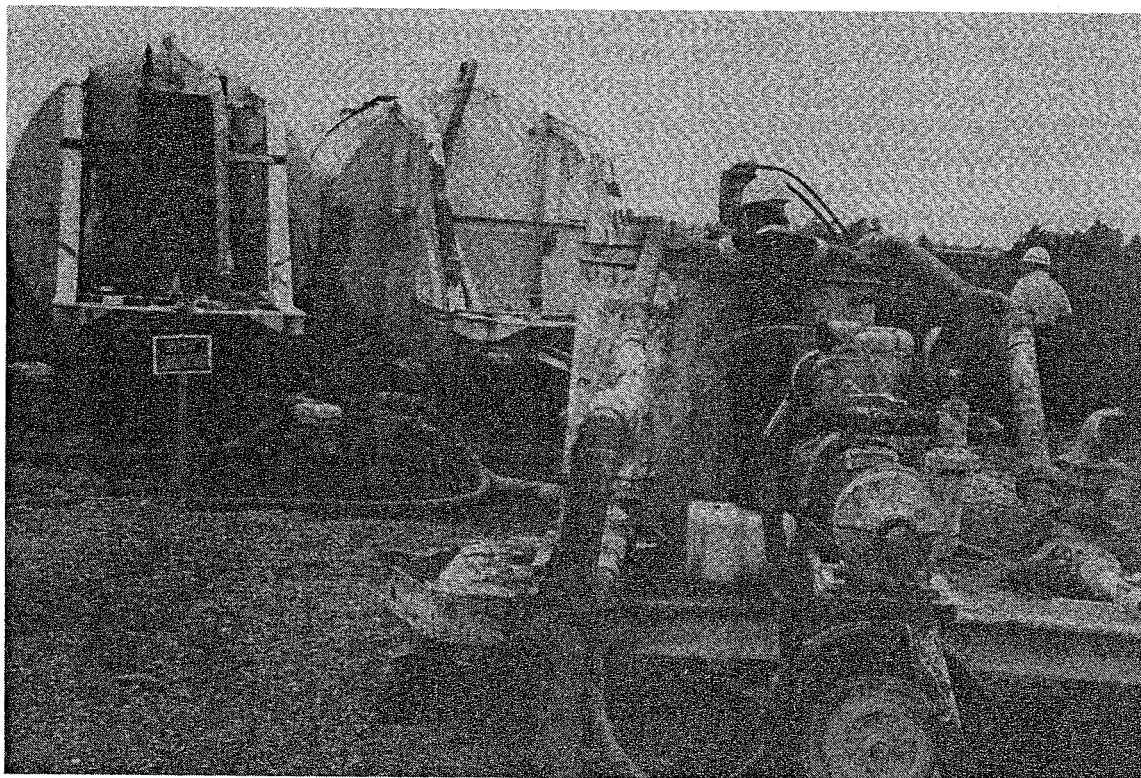
**Figure 1. Materials tanks, mixing unit, and relay pumps for lime-fly ash slurry pressure injection**

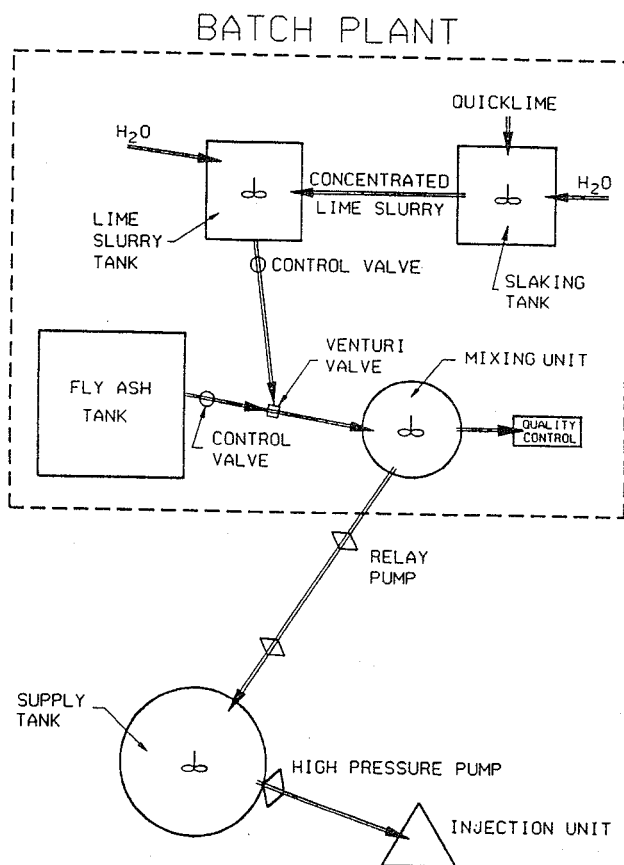
**Figure 2. Schematic showing batch plant for lime-fly ash slurry**

To obtain the specified slurry, the contractor initially slaked an entire tank load of quicklime, creating a highly concentrated mixture of hydrated lime. When lime slurry was needed, a predetermined amount of this concentrate was transferred to a second tank and diluted with water. This lime slurry was then pumped continuously through a venturi valve and into the adjacent mixing unit (Fig. 1). At the venturi valve, fly ash was blown in from a separate tanker. As part of the quality control program, specific gravity tests were performed every five minutes or whenever there appeared to be any changes in the consistency of the slurry within the mixing tank. When the specific gravity was outside the requirements for the design mixture, the contractor chose to make adjustments to the rate at which fly ash entered the venturi valve. Relay pumps were used to transfer the slurry from the mixing tank to a larger holding tank near the injection site. This tank was of sufficient capacity to prevent the interruption of the slurry supply when the venturi valve clogged or when the concentrated lime slurry was being transferred. A high-pressure pump was used to transfer the slurry from the holding tank to the injection unit. This pump was capable of maintaining a constant pressure of 50 psi and producing an instantaneous pressure of 200 psi at the injection unit. All of the units holding lime or lime-fly ash particles were

continuously agitated to ensure uniform dispersion of the particles. Figure 2 shows a schematic of the mixing operation.

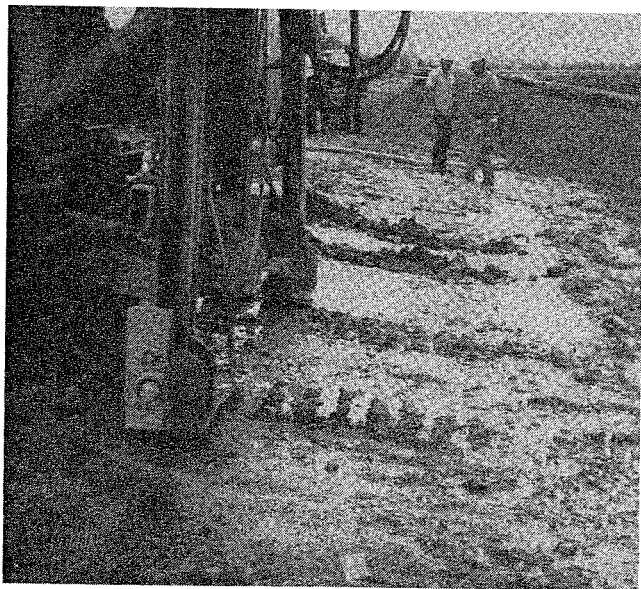
**Figure 3. Injection unit for lime-fly ash slurry is attached to bulldozer**

The injection unit was a small track dozer with three independently operated injection rods attached to the front (Fig. 3). These 1/2-in.-diam rods were spaced 5 ft apart and were capable of penetrating 20 ft. The rods were pushed into the soil in 12- to 18-in. increments, and the slurry was injected at each interval until refusal was achieved. Refusal was defined as the point at which slurry ran freely from previous injection holes or from ground cracks or there was excessive blowback around the injection rods. A decision was made to increase the injection intervals to 18 to 24 in. This change reduced the amount of blowbacks and increased the amount of ground take. Other than this modification, the injection was performed according to specifications. Upon completion of the slurry injection, the remaining items of levee restoration were performed without incident.
